PENNSYLVANIA **LEVEL**
SHANGRI-LA DAM

NDI-PA 00248

PHASE I INSPECTION REPORT
NATIONAL DAM INSPECTION PROGRAM

Name of Dam: Shangri-La Dam ID #PA00248
State Located: Pennsylvania
County Located: Chester
Stream: Broad Run
Coordinates: Latitude $39^{\circ} 47.0'$, Longitude $75^{\circ} 44.4'$
Date of Inspection: (June 12, 1979),

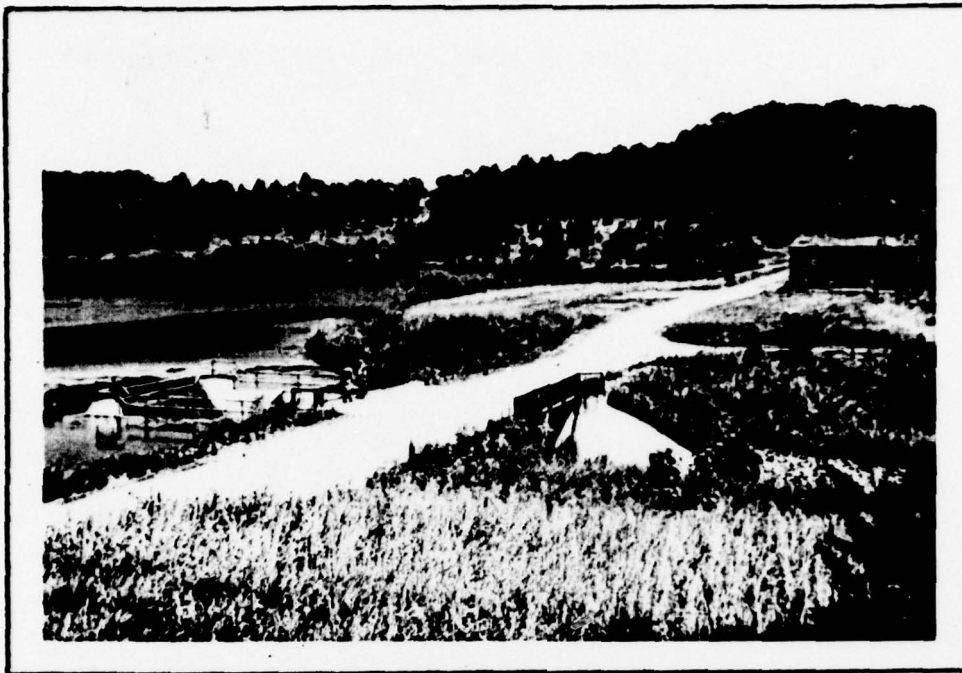
*VIEW OF THE EMBANKMENT FROM THE DOWNSTREAM
RIGHT ABUTMENT SHOWING THE SPILLWAY SYSTEM*

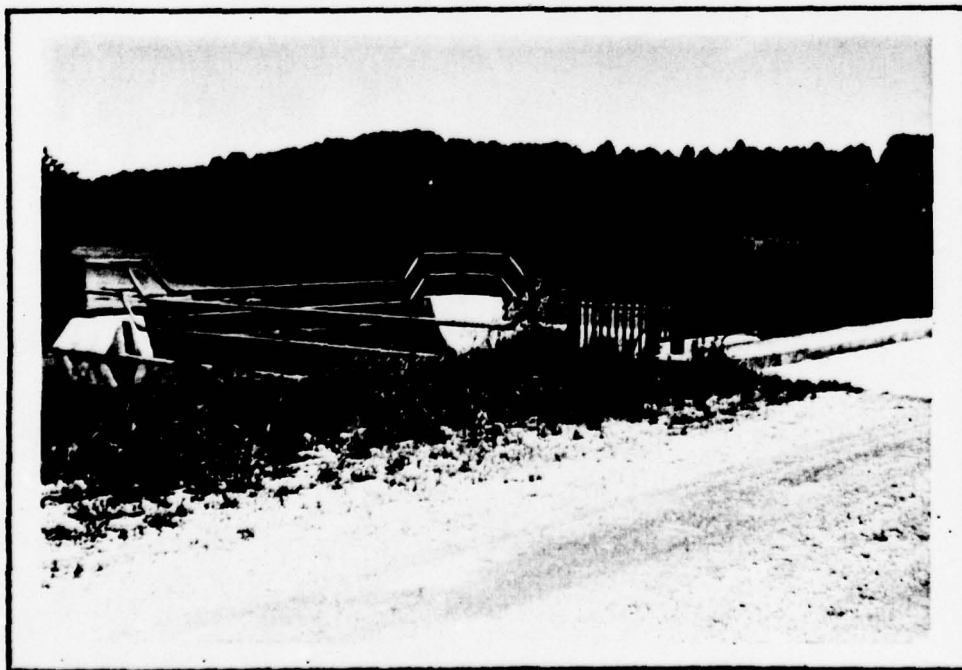
*CLOSE UP OF THE SERVICE SPILLWAY
NEAR THE RIGHT ABUTMENT OF THE DAM*

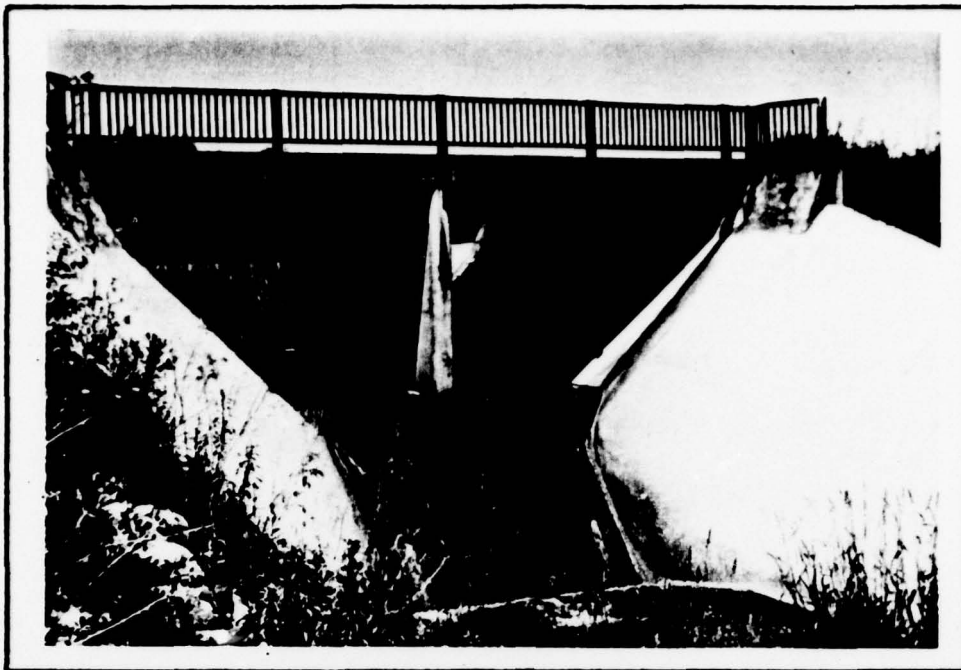
The structural features of the service spillway appear to be in good condition. On the date of the inspection, the spillway discharge channel was overgrown with weeds so that the three drop structures located in the channel could not be inspected properly.

*DROP SECTIONS THROUGH THE SERVICE SPILLWAY
LOOKING UPSTREAM*

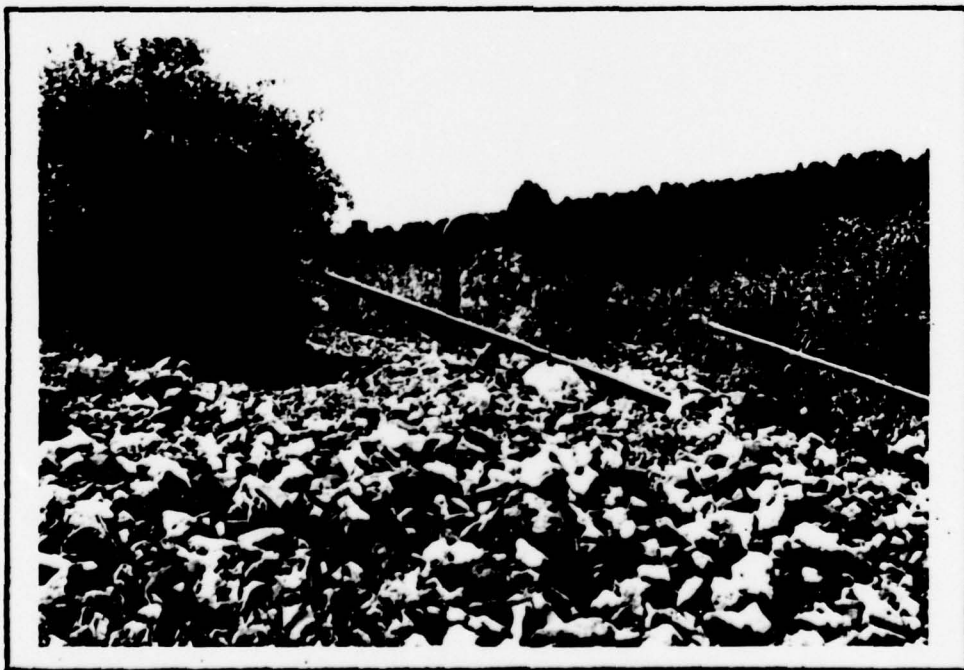
According to the Owner's representative, the operating gates are not maintained on a regular basis. At the time of inspection, the concrete structure upon which the upstream gate controls are located was overgrown with bushes and was not readily accessible. During the inspection, the hand wheel for operation of the 8-inch sluice gate was provided by Mrs. Powell. However, an adapter is required to fit the wheel to the gate stem; therefore, the operating condition of the sluice gate could not be assessed.

*RESERVOIR DRAIN HOIST STEM AND
HOIST MOUNTING BLOCK*

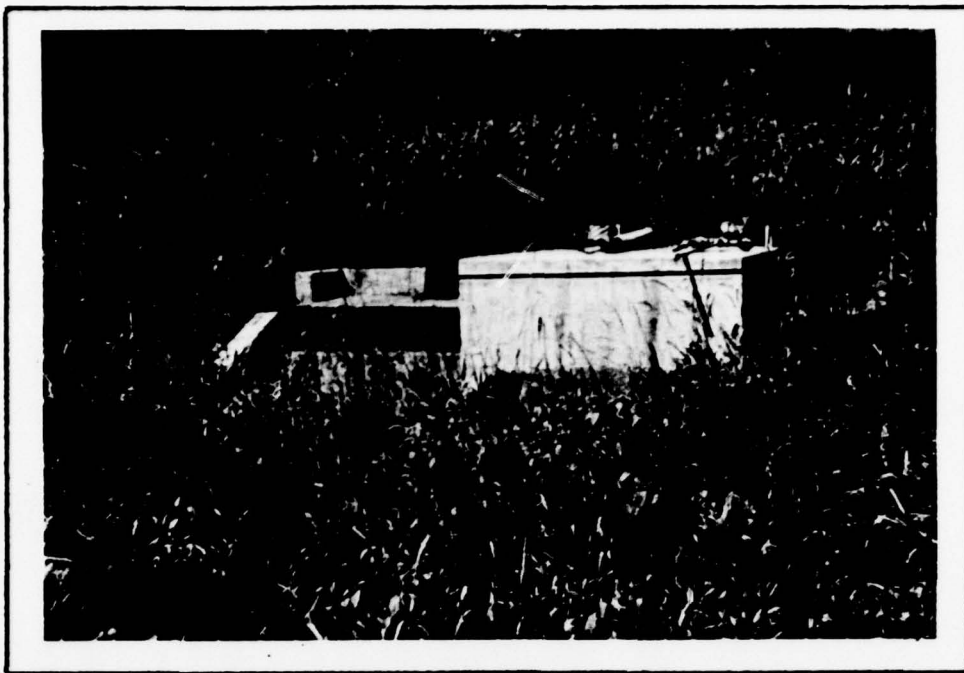
*RESERVOIR DRAIN SYSTEM IMPACT BASIN
AND BOX OUTLET STRUCTURES*

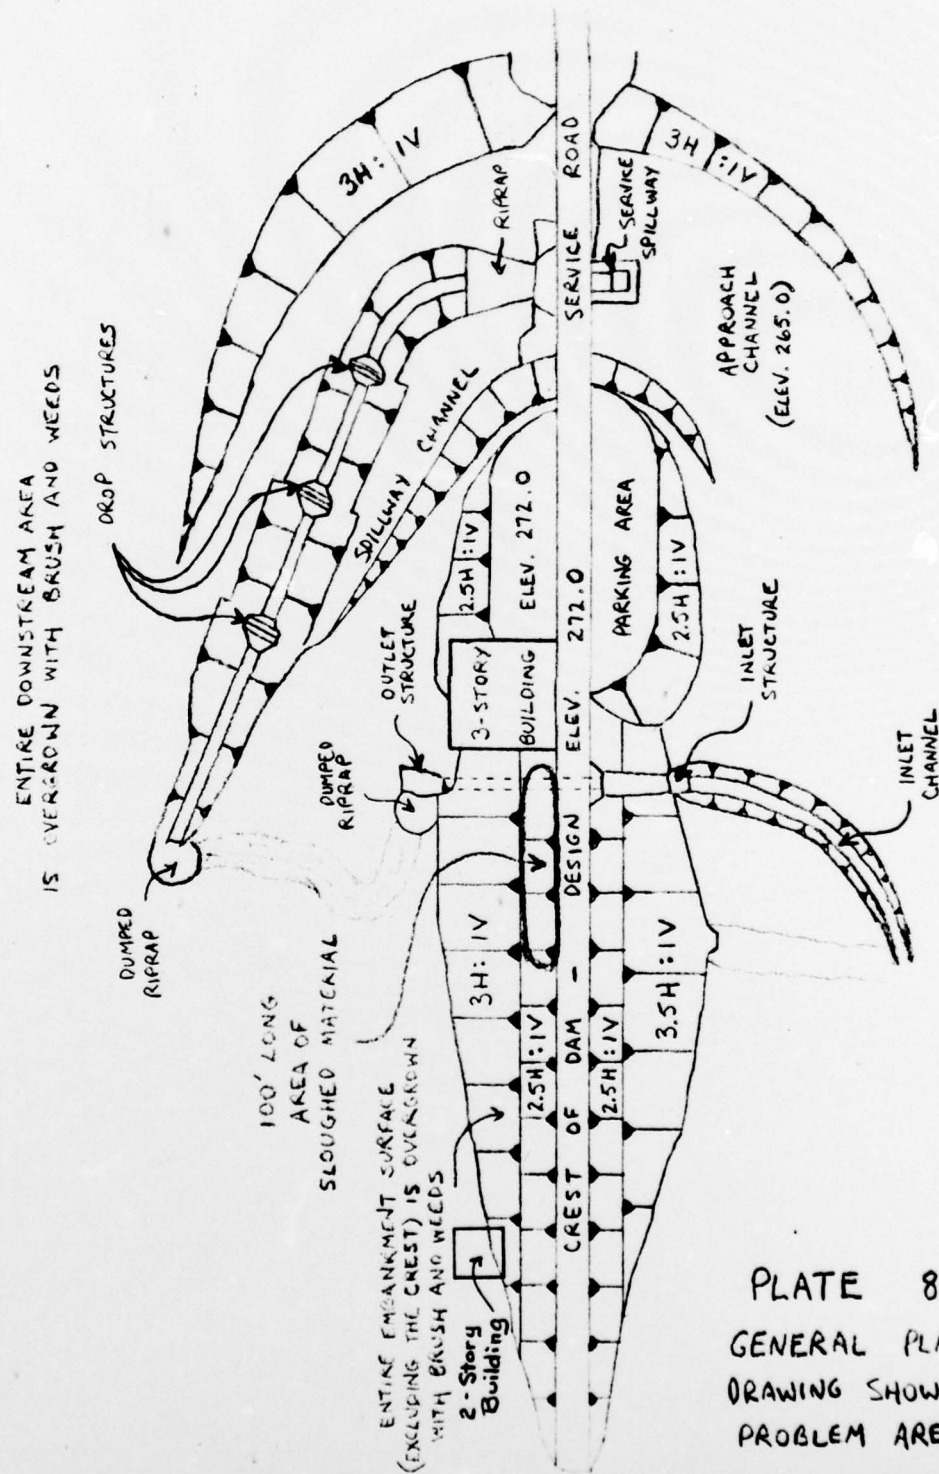
PLATE 8
GENERAL PLAN
DRAWING SHOWING
PROBLEM AREAS

b. Dam. The upstream and downstream slopes of the embankment are covered with thick weeds and brush which make it difficult to assess the condition of the slopes. Several small areas which supported no vegetation were observed near the top of the downstream slope in the general vicinity of the outlet works. The upper portion of the downstream slope in this vicinity is considerably steeper than the remainder of the slope indicating that some surface sloughing of the random fill material may have occurred.

1. The trees, brush, and weeds that have overgrown the dam, spillways and outlet channels should be removed to permit more detailed inspection of the dam. If any distress such as sloughing, cracking, or seepage is observed, the condition should be evaluated by a licensed professional engineer experienced in the design and construction of dams.
